NASA Engineering and Safety Center Technical Consultation Report	Document #: RP-05-125	Version: 1.0
Title:	STS-114 Engine Cut-off Sensor Anomaly Technical Consultation Report		Page #: 1 of 23

STS-114 Engine Cut-off Sensor Anomaly Technical Consultation Report

November 3, 2005

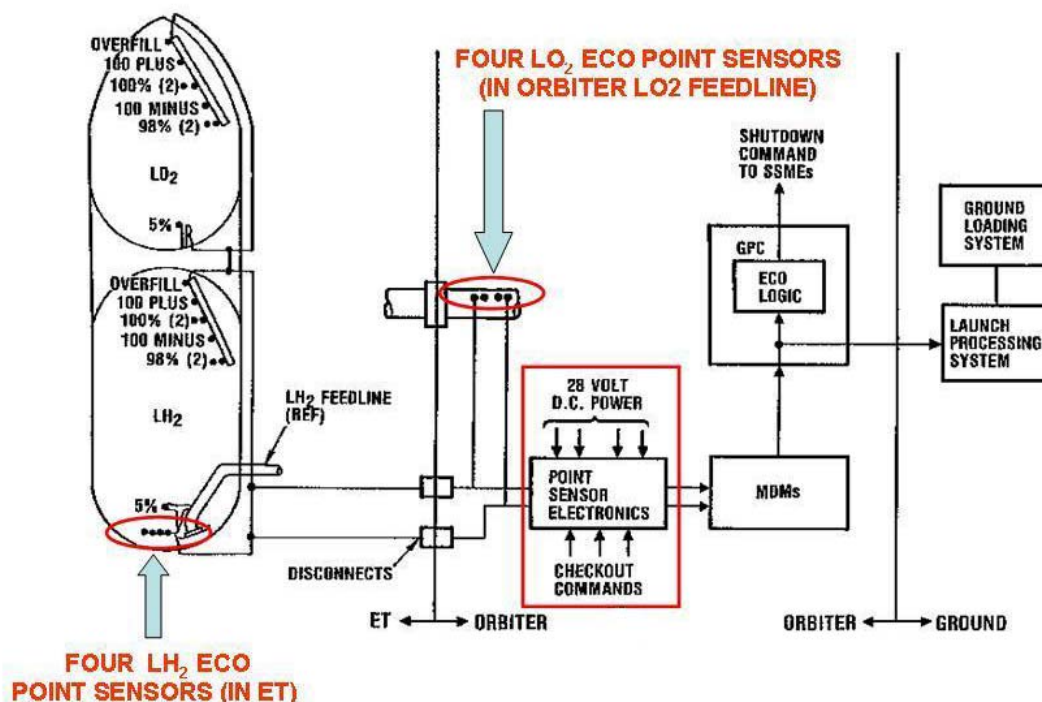
Figure 6.0-1. ECO and Liquid Level Sensors Block Diagram

The MPS ECO system consists of point-sensors installed in the ET liquid hydrogen (LH₂) tank and the Orbiter's liquid oxygen (LO₂) feedline. Point sensor electronics are designed to condition signals and to provide appropriate stimulation of the sensors and associated wiring and connectors. Refer to Figure 6.0-1 for an overall schematic.

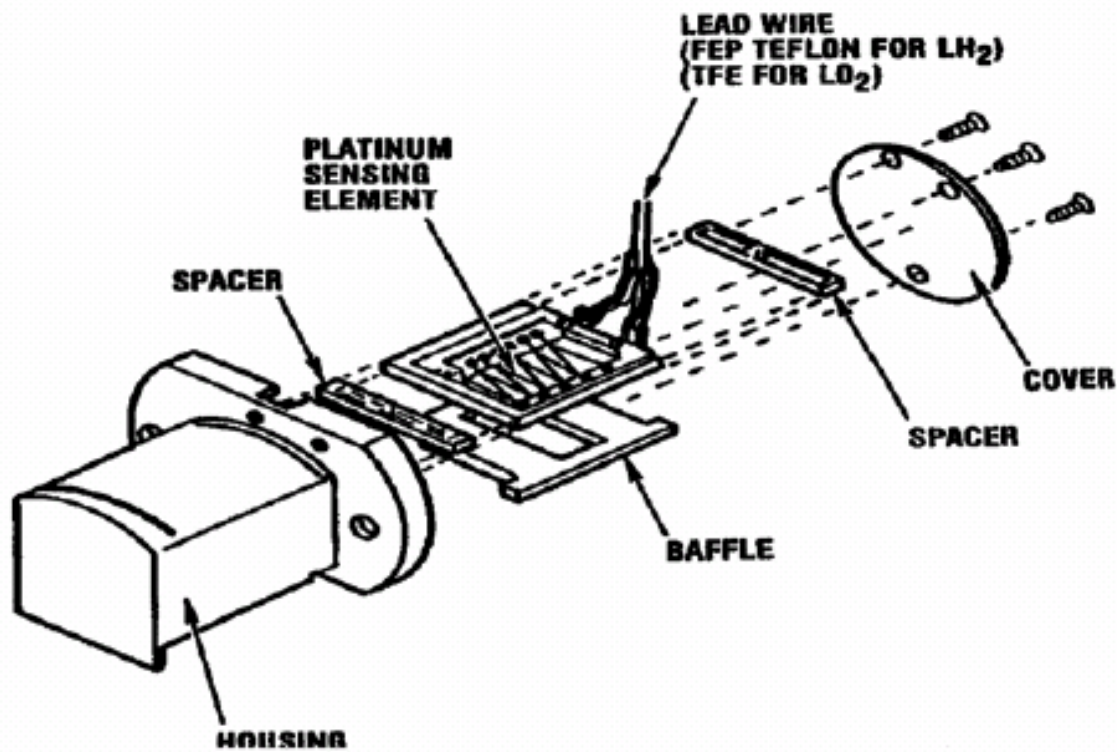
Figure 6.0-2. ECO Sensor System Overview

An ECO sensor is depicted in Figure 6.0-2. The sensor consists of a platinum wire sensing element mounted on an alumina Printed Wiring Board (PWB) and is encased in an aluminum

housing. The sensing element acts as a variable resistance which changes on exposure to cryogenic liquid. This resistance variation is detected by post-sensor (signal conditioning) electronics and is used to generate either a “wet” or “dry” indication as noted above.
